Manhole Inspection Summary

Manhole # S33E__035MH

Insp Date: 11/11/08 2:05 PM

Location Address: **14 w saratoga st**

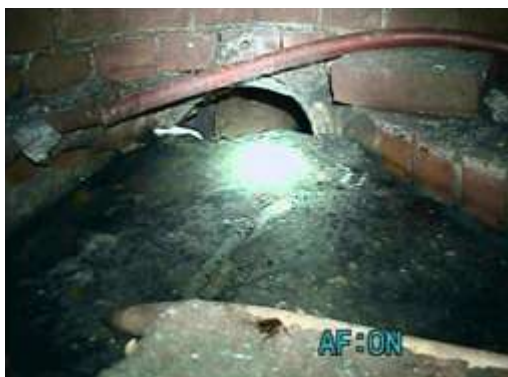
Defect 4

Condition: ☐ Sound ☐ Cracked ☐ Root Intrusion ☐ Deteriorated ☐ Leaks ☒ **Debris**

channel debris

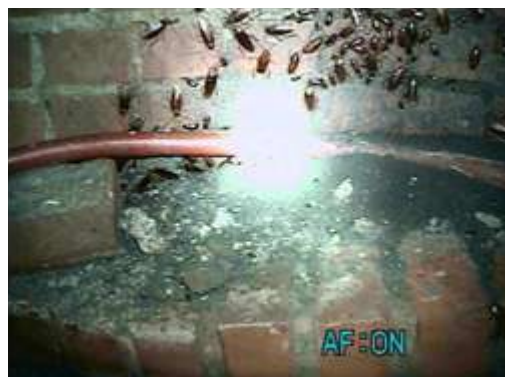
Defect 3

Condition: ☐ Sound ☐ Cracked ☐ Root Intrusion ☐ Deteriorated ☐ Leaks ☒ **Debris**

bench debris

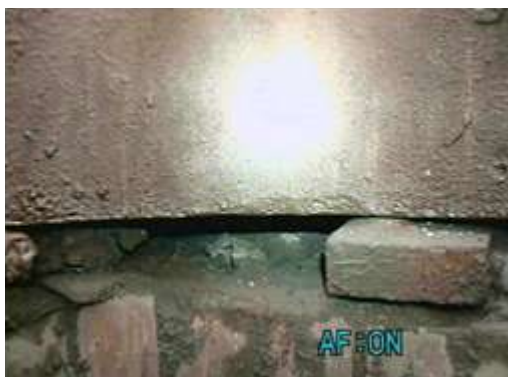
Defect 2

Condition: ☐ Sound ☐ Cracked ☐ Root Intrusion ☒ **Loose Brick** ☐ Deteriorated

Infiltration: ☐ None ☒ **Joint** ☐ Cracks ☐ Mortar ☐ Roots ☐ Wall

chimney loose bricks, infiltration at joint,
frame adj

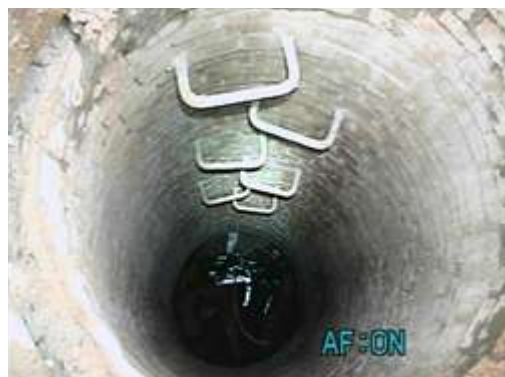
Defect 1

Count: **6** Missing: **0** ☒ **Corroded**

cor. steps

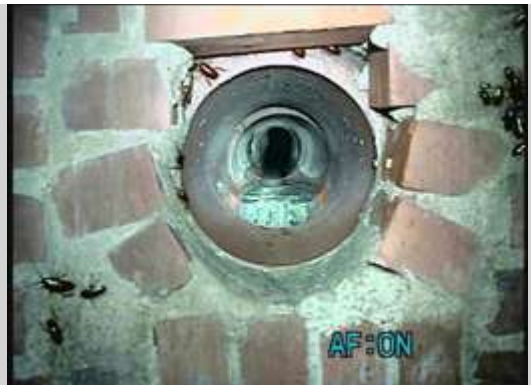
3 O'Clock Inflow

Drop: **Outside Direct**

Drop Condition: **Open**
